# **EXHIBIT Z**

# Degradation of polypropylene *in vivo*: A microscopic analysis of meshes explanted from patients

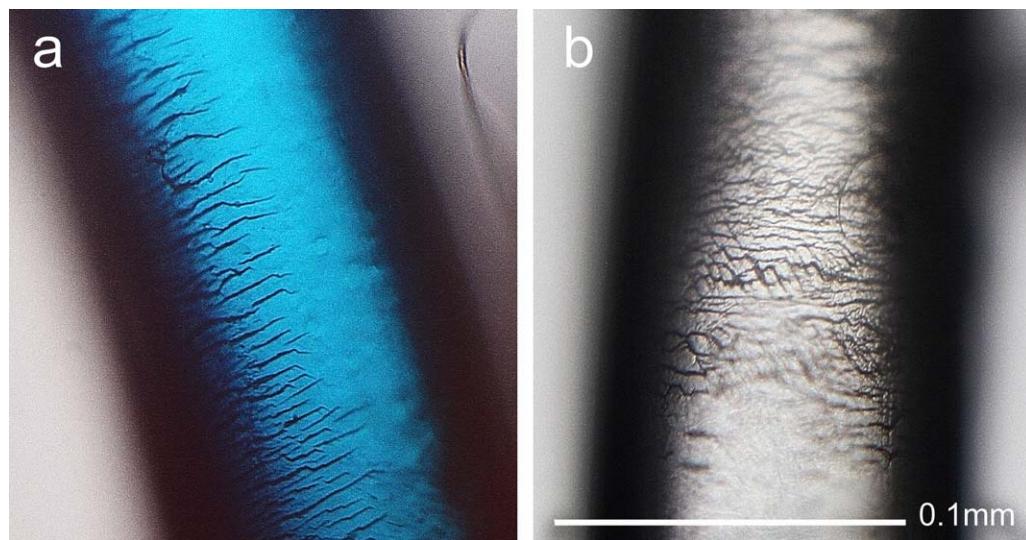
**FIGURE 1.** Surface of the mesh fibers immediately after explantation from the body, transvaginal sling explanted due to pain 9 years after implantation, light microscope,  $\times 20$  objective with image crop. Mesh fibers at the specimen edges had no covering tissue and could be examined as they were in the body, avoiding possible artifacts of tissue removal, drying or contact with formalin. Both blue (a) and clear (b) fibers showed surface cracking. [Color figure can be viewed in the online issue, which is available at [wileyonlinelibrary.com](http://wileyonlinelibrary.com).]

In one case the mesh fibers could be assessed immediately after explantation, before tissue drying or fixation in formalin. The transvaginal sling was excised because of chronic pain 9 years after implantation. Mesh fibers at the specimen edges were free of tissue and could be examined in a conventional microscope after a rinse in saline and without additional preparation (Figure 1). There were transverse cracks at the bending points [Figure 1(a)] and patches of haphazard cracks on straighter portions of the fibers [Figure 1(b)].

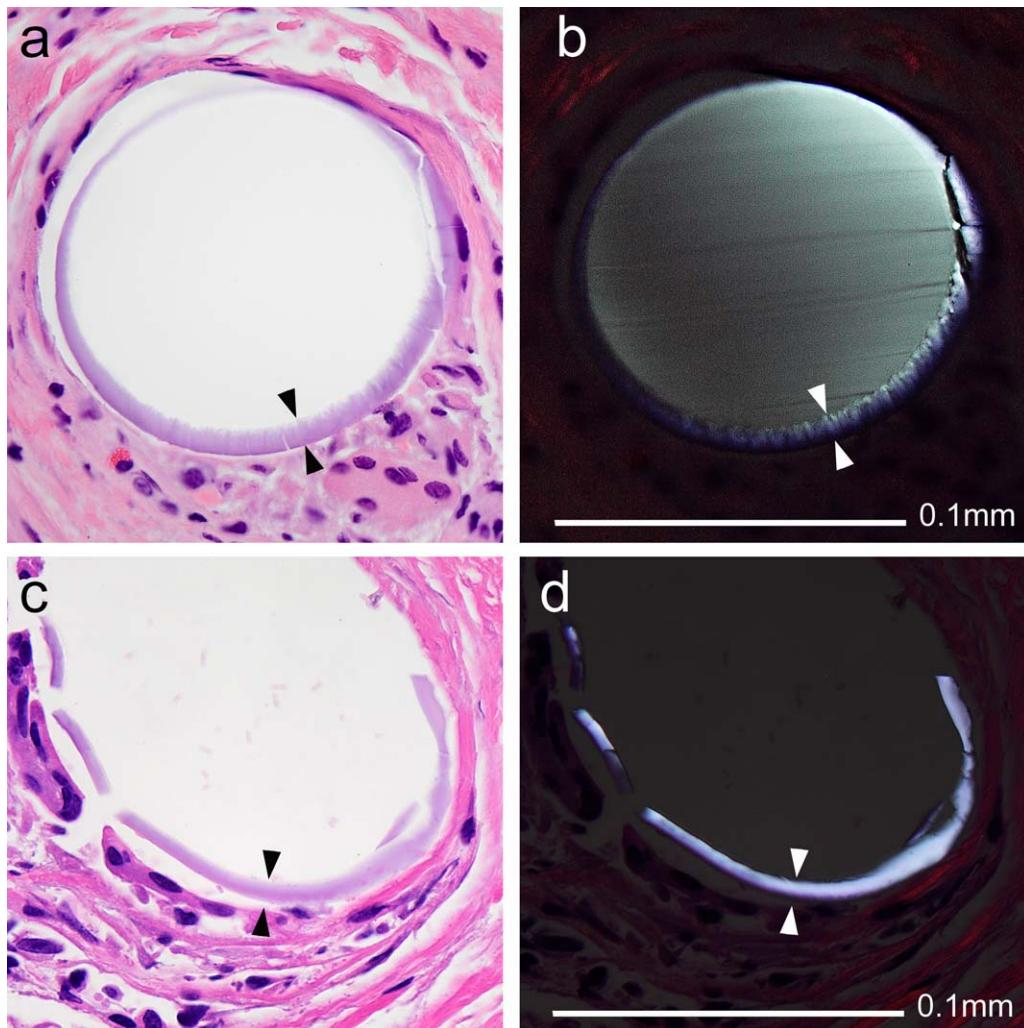
**FIGURE 2.** Histological sections, H&E stain,  $\times 100$  objective with oil immersion. The same cross section of a clear mesh fiber in regular (a) and polarized (b) light. The fiber has a layer of staining degraded polypropylene at the surface (between arrowheads). This layer has refractile properties of polypropylene in polarized light (b). In some areas the non-degraded core of the fibers detaches during histological processing while segments of the degraded layer stay attached to the tissue. Separated degradation layer in regular (c) and polarized (d) light. At sites like this, intensity of light passing through the degraded layer cannot be attributed to light scatter from the core. Note that tissue components including collagen have a much weaker birefringence than polypropylene (b and d). [Color figure can be viewed in the online issue, which is available at [wileyonlinelibrary.com](http://wileyonlinelibrary.com).]

polypropylene. In polarized light, both the central core of the fibers and the outer layer showed similar refractile properties [Figure 2(b)]. The light intensity was uniform within the core while the outer layer had gradual reduction of the refractile ability toward the surface. Birefringence of the outer layer was also observed in the segments of the "bark" separated from the core [Figure 2(c,d)]. At these sites, the light brightness in the "bark" layer was due to its internal properties and could not be attributed to the scatter of light from the core. The adjacent tissue components containing collagen also showed birefringence, however of a much lower intensity. The tissue components also had a different structure and coloration.

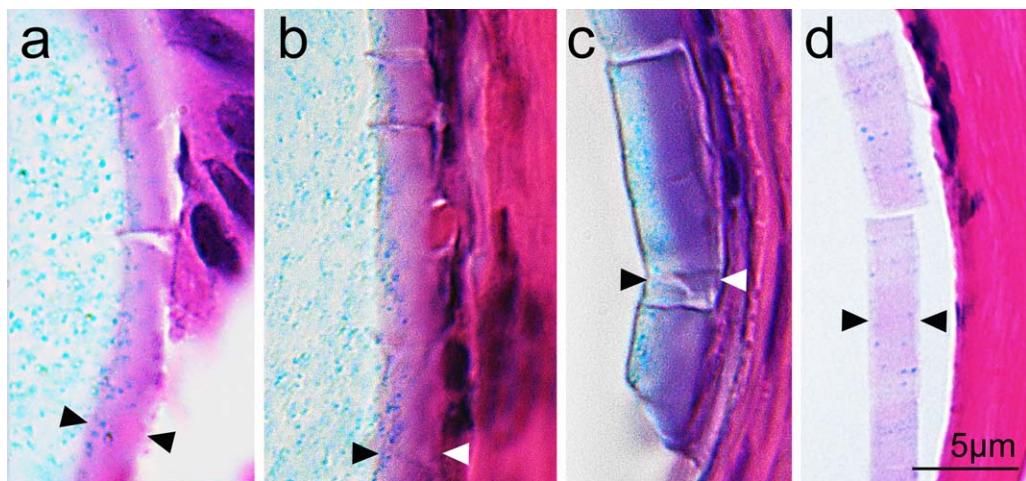
**FIGURE 3.** Degradation “bark” of the blue fibers manufactured with inclusion of blue dye granules, H&E stain,  $\times 100$  objective with oil immersion: (a) and (b) non-degraded core (left half of the images) and the degraded layer (between arrowheads). Note that the blue granules are retained in the layer of degraded polypropylene. Within the degraded “bark,” the granules degrade and lose color toward the surface. In (c) and (d) the non-degraded core detached from the slides similarly to Figure 2(c,d). At these sites, presence of the granules in the separated “bark” cannot be attributed to an overlap with the core. [Color figure can be viewed in the online issue, which is available at [wileyonlinelibrary.com](http://wileyonlinelibrary.com).]

into the material during its manufacture (Figure 3). The granules were seen in the non-degraded core of the fibers as well as to a variable degree in the outer degradation layer. In the latter, they were detected within the “bark” remaining on the core [Figure 3(a,b)] as well as in the segments of the “bark” separated from the core [Figure 3(c,d)]. The granules were mainly seen in the deeper layers of the “bark” and were not as frequent closer to the surface, which suggests that they also undergo degradation and lose color. The finding was a direct confirmation that the “bark” originated from the same material as the core of the fibers.

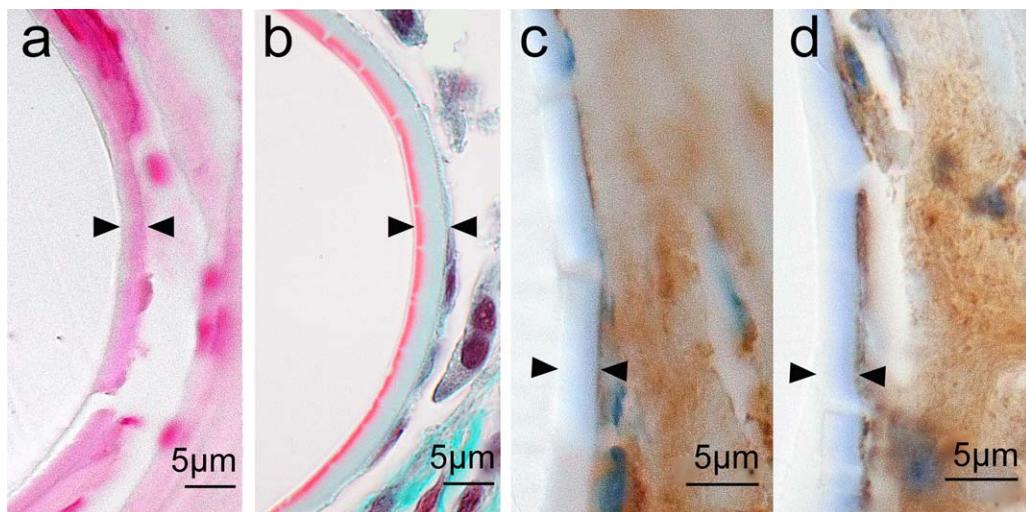
The brittleness, staining and birefringence characteristics of the “bark” were similar to those of calcium salts which are commonly deposited in degenerating tissues. Von Kossa stain was used for a sample set of 10 specimens to rule out presence of calcium salts in the outer “bark.” No calcium salts were detected in the brittle outer layer of the 10 specimens tested [Figure 4(a)].

**FIGURE 4.** Additional stains, all images taken with 100x oil immersion objective and cropped to a different magnification, polypropylene degradation layer is pointed between arrowheads: (a) Von Kossa stain is negative for calcium in the brittle “bark” (would stain calcium black), (b) trichrome stain shows that the deeper parts of the “bark” have smaller staining porosity (red) than those close to the surface (green) which correlates with TEM findings [Figure 6(b)], (c) immunohistochemical stain for immunoglobulin G (IgG, stained brown). IgG is present in almost all human tissues and fluids. It is deposited on the surface of degraded polypropylene but is not mixed within it. (d) Immunostain for the oxidizing enzyme of inflammatory cells myeloperoxidase (stains brown). [Color figure can be viewed in the online issue, which is available at [wileyonlinelibrary.com](http://wileyonlinelibrary.com).]

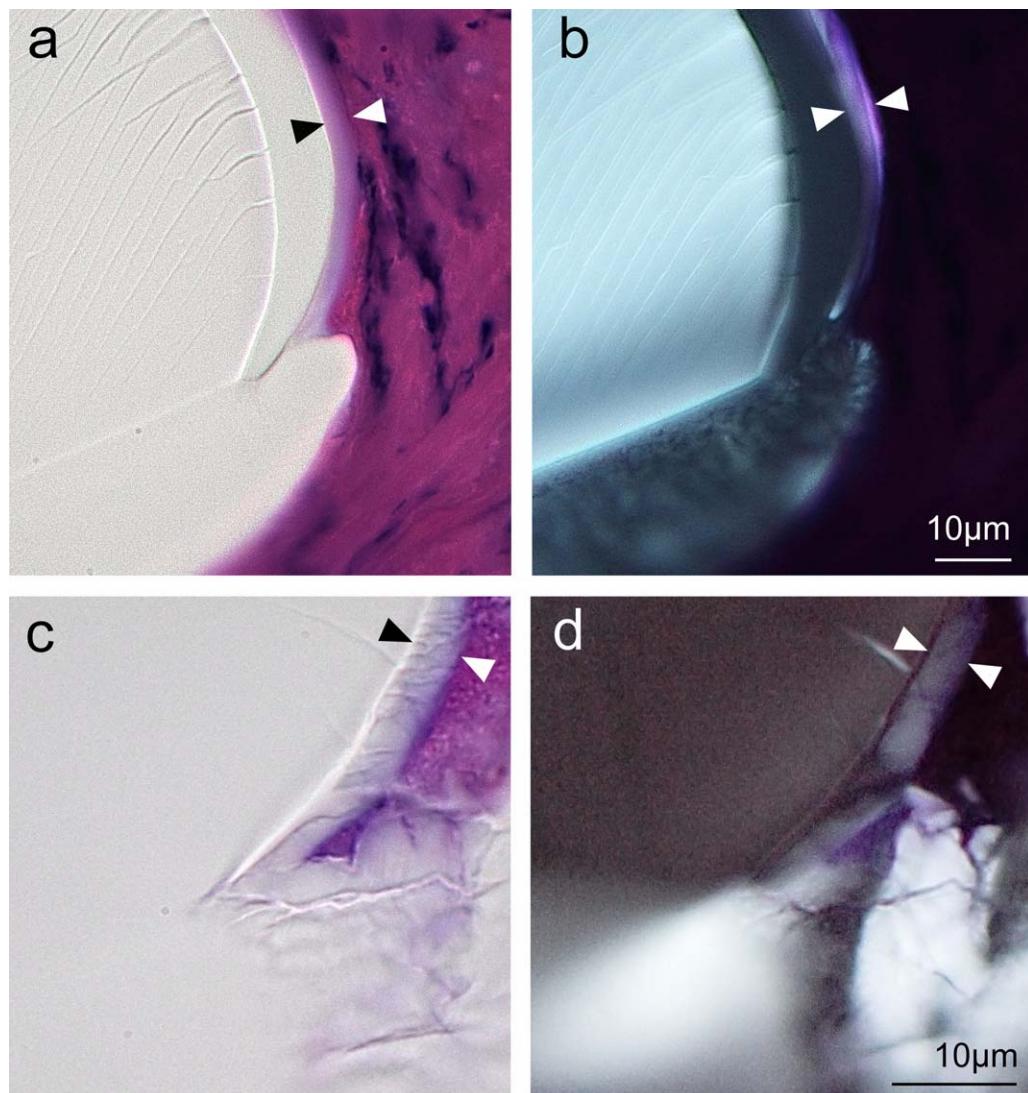
**FIGURE 5.** Melting of both non-degraded and degraded polypropylene caused by the surgical cautery, H&E,  $\times 100$  oil immersion: (a) and (b) the same site of fiber melting in regular and polarized light, (c) and (d) another site showing melting point. While molten the non-degraded core and the degradation “bark” formed a common pool of material. [Color figure can be viewed in the online issue, which is available at [wileyonlinelibrary.com](http://wileyonlinelibrary.com).]

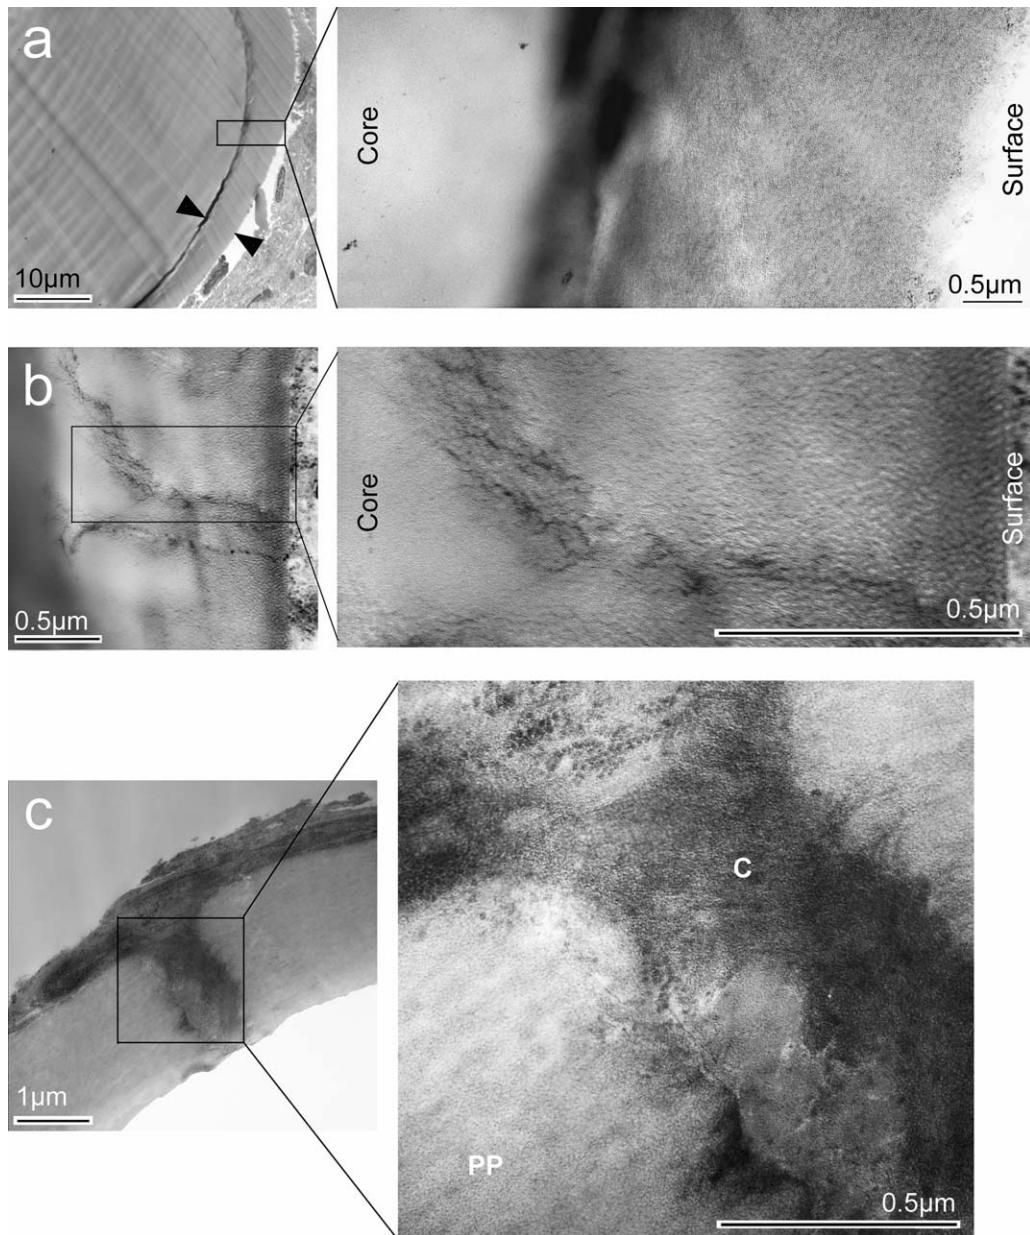
We used TEM to study the ultrastructural organisation of the degraded layer in cross sections. The mesh fibers showed an outer "bark" similar to that seen by light microscopy [Figure 6(a)]. There were no fibrillary (collagen, amyloid etc.) or other structures of connective tissue matrix within the "bark". Material composition of the outer layer and the core showed similar electron density; however, at high magnification the outer "bark" was noticeably more granular, especially toward the surface [Figure 6(a), insert].

The "bark" material had a lattice of fine branching cracks (nanocracks). This network of nanocracks was sparse closer to the core and expanded toward the surface [Figure 6(b)]. As seen in Figure 6(b) in addition to the nanocracks there were also occasional larger cracks occurring at random. These larger cracks seen by TEM corresponded to the cracks seen by light microscopy either on the surface (Figure 1) or in cross sections (Figure 2).

The "bark" either had a gradual transition into the core [Figure 6(b)] or showed a zone of circumferential fissuring partially separating it from the core [Figure 6(a)]. The mechanisms of "bark" separation from the core and formation of the larger cracks are likely linked since the cracks tended to turn at the interface between the "bark" and the core [Figure 6(b)]. The forces which produced the transverse (radial) cracks also acted as shear forces between the "bark" and the core.

An important finding was the detection of inflammatory cells partially migrated into and trapped within the fissures as shown in Figure 6(c). The shape of widened crevices and the depth of penetration indicated an active *in vivo* cellular migration. This phenomenon was observed at two separate sites.

**FIGURE 6.** Transmission electron microscopy. (a) Low power magnification of a cross-sectioned mesh fiber shows the degradation layer similarly to light microscopy, the insert shows an image composed of three high power fields to reconstruct the transition between the non-degraded core and the degradation “bark.” Note the fine nanocracks/nanopores in the degraded material. (b) Outer part of the fiber with gradual transition between the non-degraded core and the degraded polypropylene at the surface. The lattice of nanocracks expands toward the surface (left to right). There are also two larger cracks which start perpendicular to the surface but then turn at the interface between the core and the degraded layer. (c) A part of inflammatory cell (labeled C in insert) is trapped in a fissure within the degraded polypropylene (PP). Higher magnification (insert) shows cellular membrane at the cell-polypropylene interface (left wall of the fissure) and cellular organelles in the cell (chains of rounded structures, likely ribosomes).

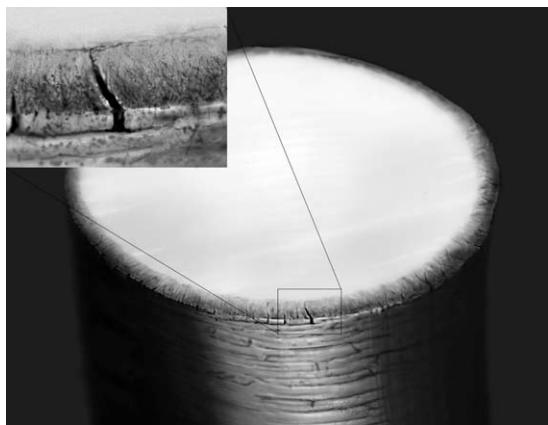
For better demonstration of the degradation "bark" we used light microscopic and TEM images to generate a 3-dimensional restoration of a mesh fiber (Figure 7).

**FIGURE 7.** A three-dimensional restoration of a cross sectioned mesh fiber.

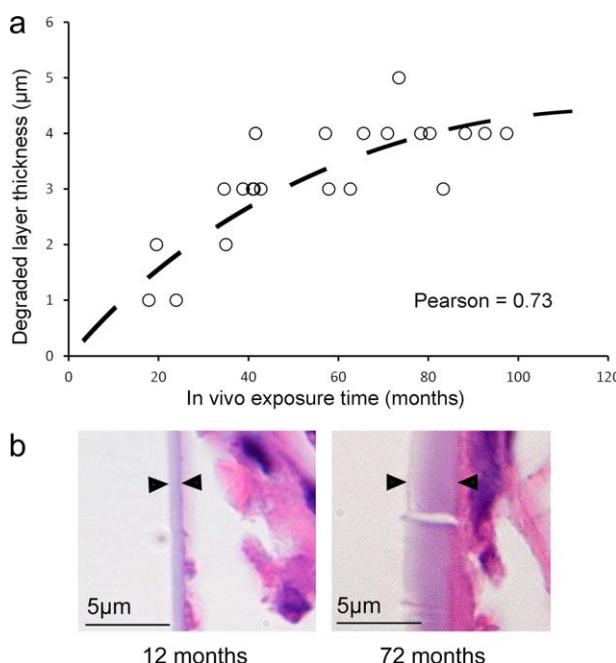
Out of all the specimens, 23 samples of explanted midurethral slings formed the largest group of meshes from the same manufacturer, of identical mesh type and with reliable records of implantation and excision dates. The range of *in vivo* interval (between implantation to excision) in the group was 18–97 months (mean 53). There was a good correlation (Pearson = 0.73) between the thickness of the degradation layer and the duration of *in vivo* exposure indicating that the thickness of degraded material grows while the mesh is in the body [Figure 8(a,b)]. There was a trend for a more rapid initial growth with gradual plateau subsequently.

**FIGURE 8.** Duration of *in vivo* exposure versus thickness of degraded layer in a group of explants of the same manufacturer and the same mesh design. (a) Thickness of the degradation "bark" increased over the years *in vivo* (Pearson correlation = 0.73). Note the trend of plateauing after 5–6 years. There was no correlation of the thickness with the duration of specimen storage in formalin (not shown, Pearson = -0.06). (b) Comparison of the "bark" in meshes explanted after 12 and 72 months in the body, H&E,  $\times 100$  objective with oil immersion, images cropped to the same magnification factor. [Color figure can be viewed in the online issue, which is available at [wileyonlinelibrary.com](http://wileyonlinelibrary.com).]
